# Qualification of the CMS Digital Optohybrid

# CMS Control Link Digital Optohybrid (DOH)

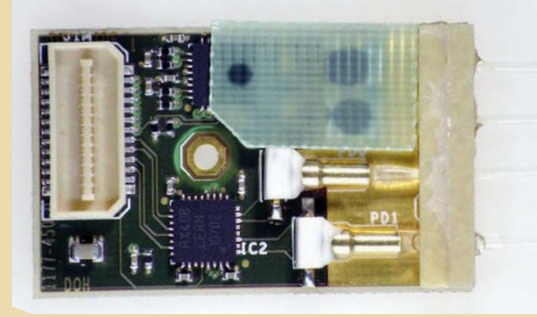
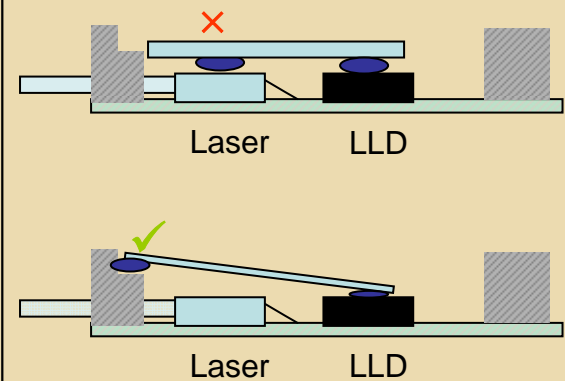
CERN fibre clamp

- DOH has undergone an extensive series of tests
  - Good functionality
  - Quality of assembly
    - 1<sup>st</sup> Pre-production failed visual inspection
    - 2<sup>nd</sup> Pre-production much better:
      - Redesigned fibre clamp
      - Redesigned assembly jig
- Remaining issues
  - Buffer ruptures on fibres
  - Soldering of photodiodes onto DOH pcb
- Production phase
  - 100 DOHs in August 04
  - Expect to reach production rate of ~200 DOHs/month

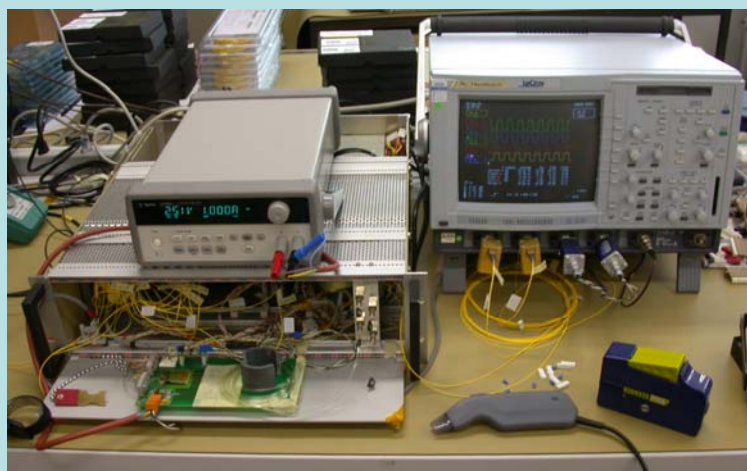
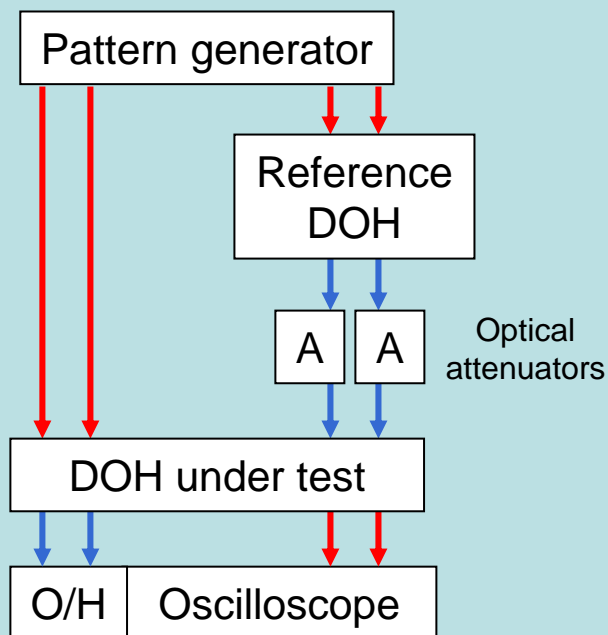
Buffer rupture

Inspection test	# failures
Fibre clamp	10
Laser cover	20
QR code	2
Soldering	12
Fibre buffer rupture	5

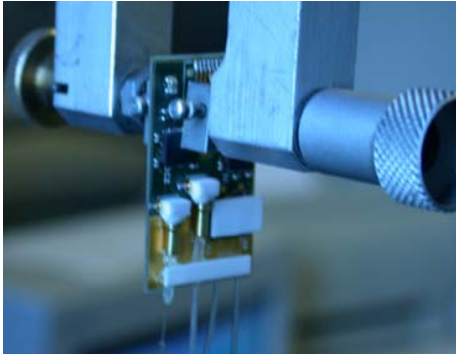
- Attach 700g to fibre
- 3/40 fibres failed (all lasers)

- Pull fibre until it fails
- 2/36 fibres below spec (all lasers 5.5N & 6.7N)

- Fibre strength reasonably good
- Revise DOH pull strength specification
