Status of the Environmental Quality Assurance Programme for Lasers in Optical Links for Readout and Control Systems in CMS.

Abstract

The status of the pre-production and production QA programme is reviewed for the environmental compliance tests of lasers to be used in the optical link systems in the CMS Tracker, ECAL, Pixels and Preshower. Three advance validation tests of seven wafer lots of lasers have now been made with very few failures, leading to the acceptance of 35000 lasers for final production.

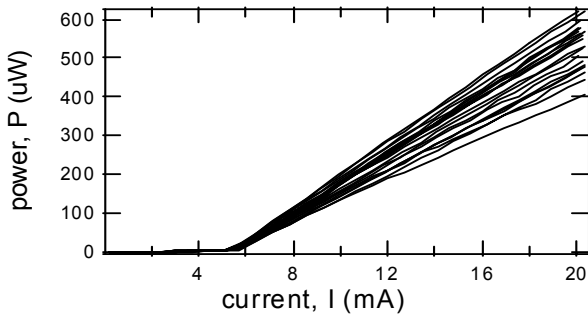
The L-I (light-power vs current) characteristics from 20 new lasers are shown in Fig. 3. These data are typical of all the samples measured in the three AVTs made to date: the initial laser threshold currents are around 5mA at 20°C and the output efficiencies (out of the fibre) are ~40μW/mA (±20%) as specified for the application. The threshold current is where the laser 'turns-on' and the efficiency is the slope of the L-I characteristic above this point.

Figure 3: Typical L-I characteristics of 20 laser die packaged and supplied by ST Microelectronics (for AVT0). The light power is that measured out of the fibre.

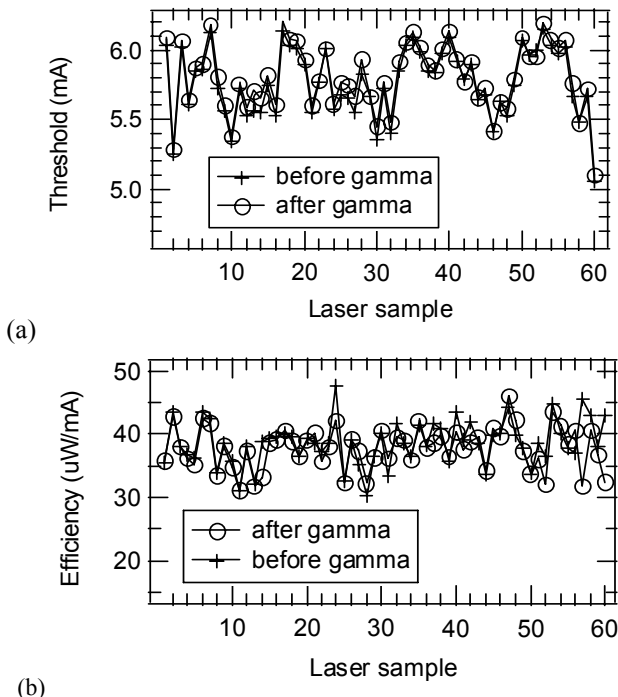
Figure 4: (a) Threshold and (b) output efficiency of sixty lasers before and after 100kGy gamma irradiation. Data from AVT 2.

Figure 4 shows the threshold current and output efficiency of lasers before and after 100kGy gamma irradiation, at room temperature without bias. The data are for 60 lasers from 3 different wafer lots in AVT2.

Apart from small variations in efficiency, which might be partly due to the radiation-damage induced losses in the 2m long fibre pigtails, there was no other significant damage. This result is similar to that of earlier tests during qualification[6]. Also, the samples tested in AVT0 and AVT1 showed no significant damage after gamma irradiation.

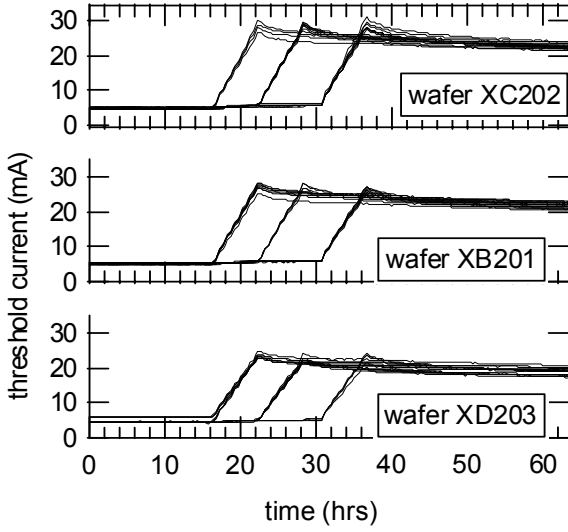
Figure 5: Threshold current measured during the neutron irradiation test to $4.5 \times 10^{14} \text{n/cm}^2$. Data from AVT 1.

The properties of the lasers are much more influenced by irradiation with high energy neutrons. The threshold current increase due to neutron radiation damage is illustrated in Fig. 5, which shows measurements made before, during and after irradiation in AVT1.

Each graph in Fig. 5 corresponds to the twenty lasers from a given wafer-lot. The different times at which the damage occurred result from the devices being separated into 3 groups, with a mixture of devices from each wafer-lot per groups. The entire 60 lasers could not be placed in the neutron beam at the same time therefore only 20 lasers from the different three wafers were irradiated at a time. The mixing of the lasers from different lasers was also a precaution against possible problems with the neutron beam, which was reserved for a fixed time-period.

The neutron flux was constant during the irradiation periods. As in the earlier qualification tests[6], the threshold current increases in proportion to the neutron fluence. The threshold increase in all the lasers is in the range of 20-25mA with only a small variation across all the devices, from all of the wafer-lots.

There is a small amount of annealing during irradiation, followed by continuous annealing afterwards. During the qualification measurements[6] the annealing was observed to be proportional to $\log(t_{anneal})$. In 17 days of monitoring after irradiation in AVT 1, ~45% of the threshold damage was annealed.

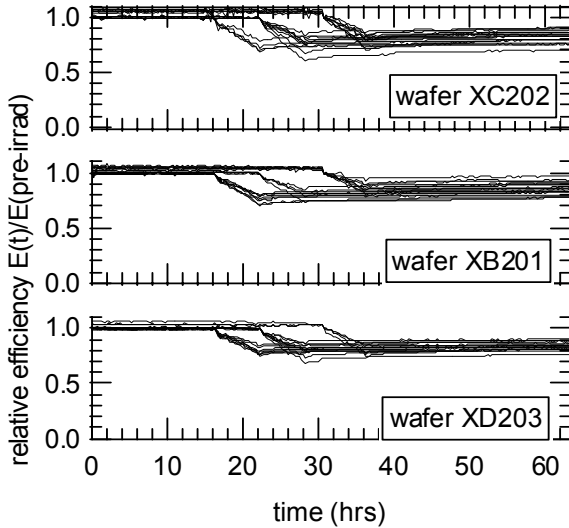
Figure 6: Normalized laser efficiency measured during the neutron irradiation test to $4.5 \times 10^{14} \text{n/cm}^2$. Data from AVT 1.

The efficiency loss due to neutron damage is shown in Fig. 6, with data also from AVT 1. The data are presented with the efficiency losses normalized to the value measured just before the start of irradiation. Overall, the efficiency decreases by approximately 20%. There is a larger variation in the damage across the devices than for the threshold damage, an effect which is not understood. As with the threshold damage, 17 days of annealing after irradiation reduced the damage by ~45%.

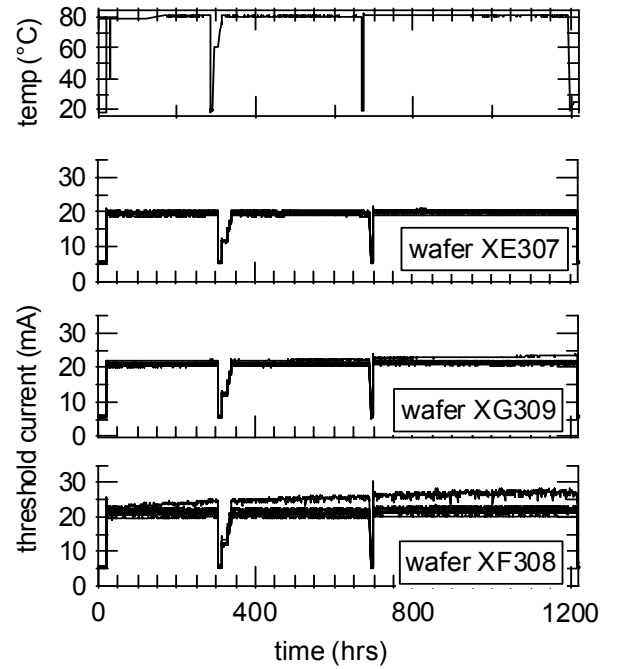
Figure 7: Threshold current measurements of unirradiated lasers during aging at 80°C. Data from AVT 2.

Fig. 7 shows data from the threshold current measurements made during aging in AVT 2, including some brief periods at 20°C. Only two lasers showed any measurable

degradation, with an increase of up to 5mA after 1200 hours, measured at 80°C. This degradation was much smaller when measured at 20°C, only 0.8mA.

Similar small wearout effects were measured for AVT0 and AVT1. However, in AVT 0 all the devices had a measurable degradation and further tests are on-going at CERN to determine whether the AVT 0 wafer lot is different to a 'standard' lot. This will be done by first of all comparing the activation energy for wearout measured on AVT 0 lasers, based on accelerated aging made at different temperatures, with that measured by Mitsubishi during their internal qualification and re-qualification tests.

Assuming, for the time-being, that the same activation energy of 0.73eV can be used for the current lots of AVT lasers, ageing at 80°C for 1000 hours corresponds to 3.6×10^6 hours at −10°C, for the operating temperature within CMS Tracker, or 1.4×10^5 hours at 20°C, more typical of CMS ECAL.

Given these large acceleration factors and the small degradation measured at 80°C, the lasers are expected to be sufficiently reliable for use in the CMS optical link systems which have a nominal 10-year lifetime.

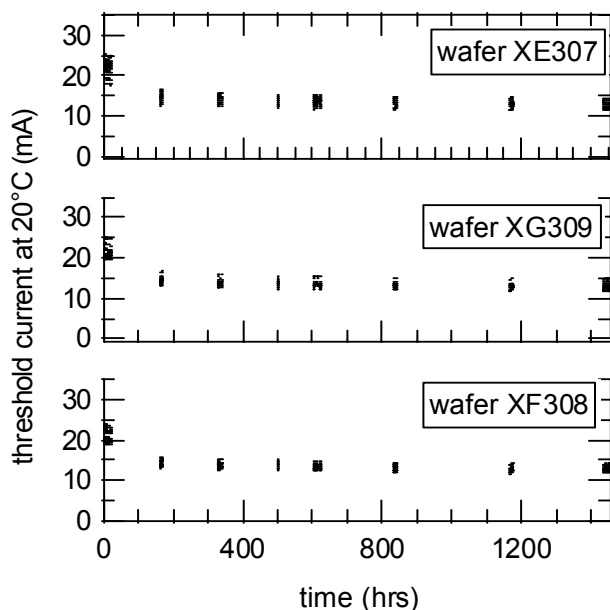
Figure 8: Threshold current of irradiated lasers (measured at 20°C) during the aging at 80°C. Data from AVT 2.

Fig. 8 shows the threshold current of the lasers mesured during the brief periods of 20°C. The threshold values at 20°C vary little due to the influence of the aging at 80°C, except in terms of the annealing, which is concentrated in the earlier times.

In all the AVTs there is no observable (gradual) wearout in any of the irradiated lasers when the L-I measurements are made at 20°C. Only annealing is seen and it is concluded that the radiation damage does not influence the wearout characteristics significantly.

However, in AVT 1 and in AVT 2, some failures have occurred. One laser in AVT 1 and one laser in AVT 2 appeared to fail due to an open circuit. These failures have not led to disqualification of a wafer-lot, since the overall acceptance criteria allow for one failure per wafer-lot. The failed devices are now being investigated further in order to diagnose the failure mechanism more precisely.
