# Qualification of the CMS Digital Optohybrid

# CMS Control Link Digital Optohybrid (DOH)

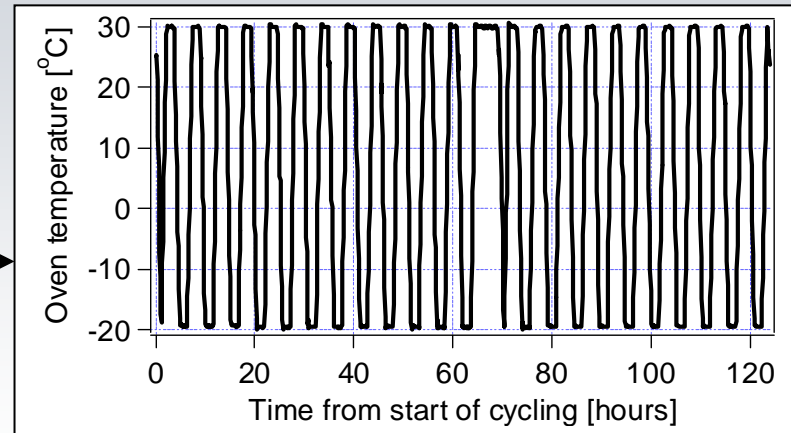
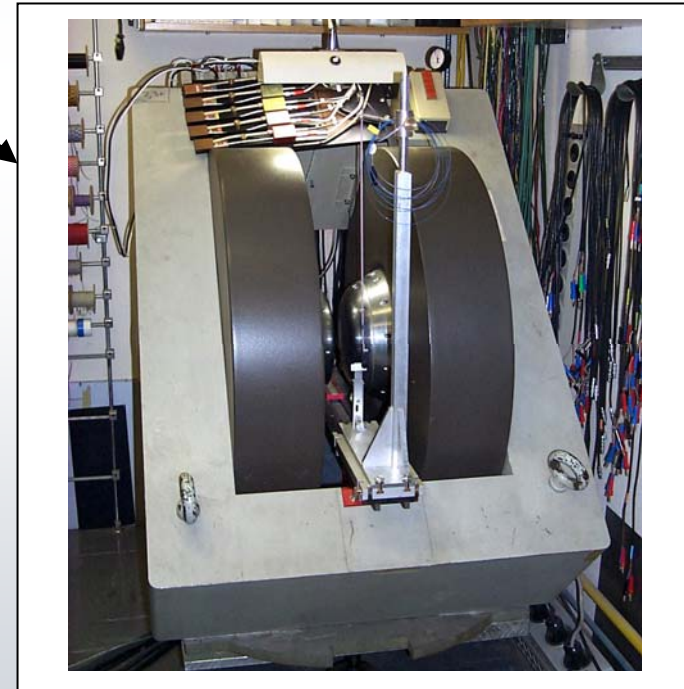
# Environmental Tests

- Temperature cycling (CERN)
- B-field (CERN)
  - 2 DOHs, 3 orientations, 2.4 T
- Shock test (Kapsch)
  - 6 DOHs, 20G
- Vibration test (Kapsch)
  - 6 DOHs, 10Hz-500Hz
- All DOHs were functional after above tests

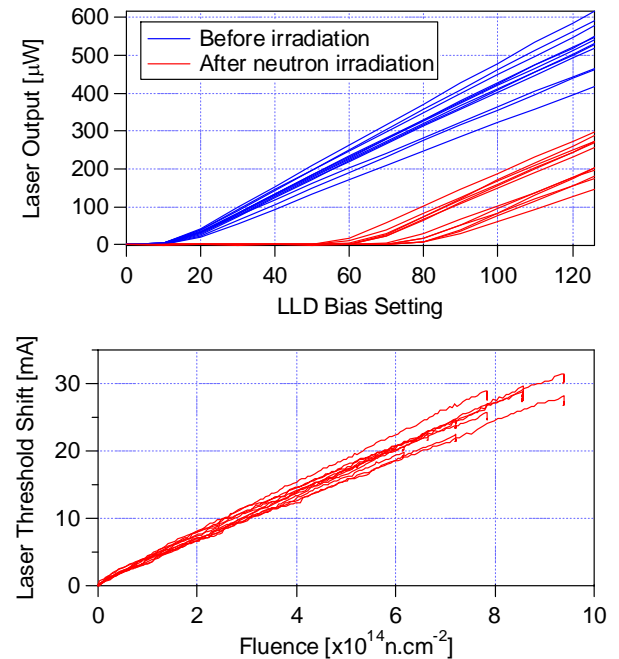
## LASERS

- Irradiation (6 DOHs)
  - 100kGy Co-60 gamma
  - Up to  $9.4 \times 10^{14} \text{ n/cm}^2$  (UCL  $\sim 20 \text{ MeV}$ )
- Expected laser and photodiode damage
- Final system laser threshold shift should be less:
  - $\sim 6 \text{ mA}$  (LLD bias shift = 13)

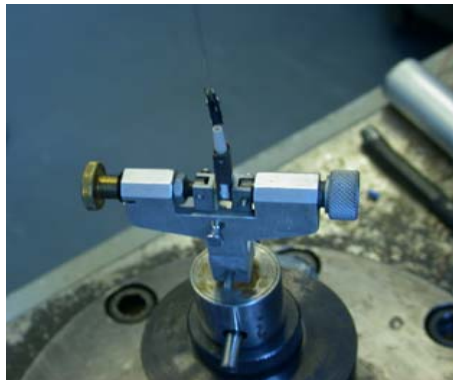
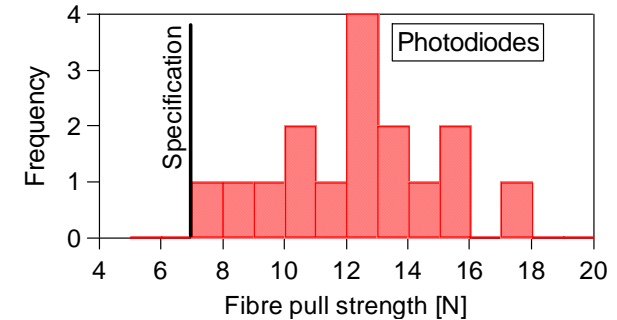
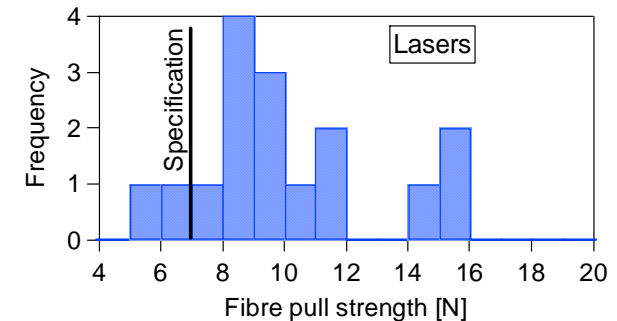
# Pull Tests

- Attach 700g to fibre
- 3/40 fibres failed (all lasers)

- Pull fibre until it fails
- 2/36 fibres below spec (all lasers 5.5N & 6.7N)

- Fibre strength reasonably good
- Revise DOH pull strength specification
